OPTIMIZING A SOUTHEASTERN PAPER MILL

Updating a Historic Dust Collector and Fan System for Savings

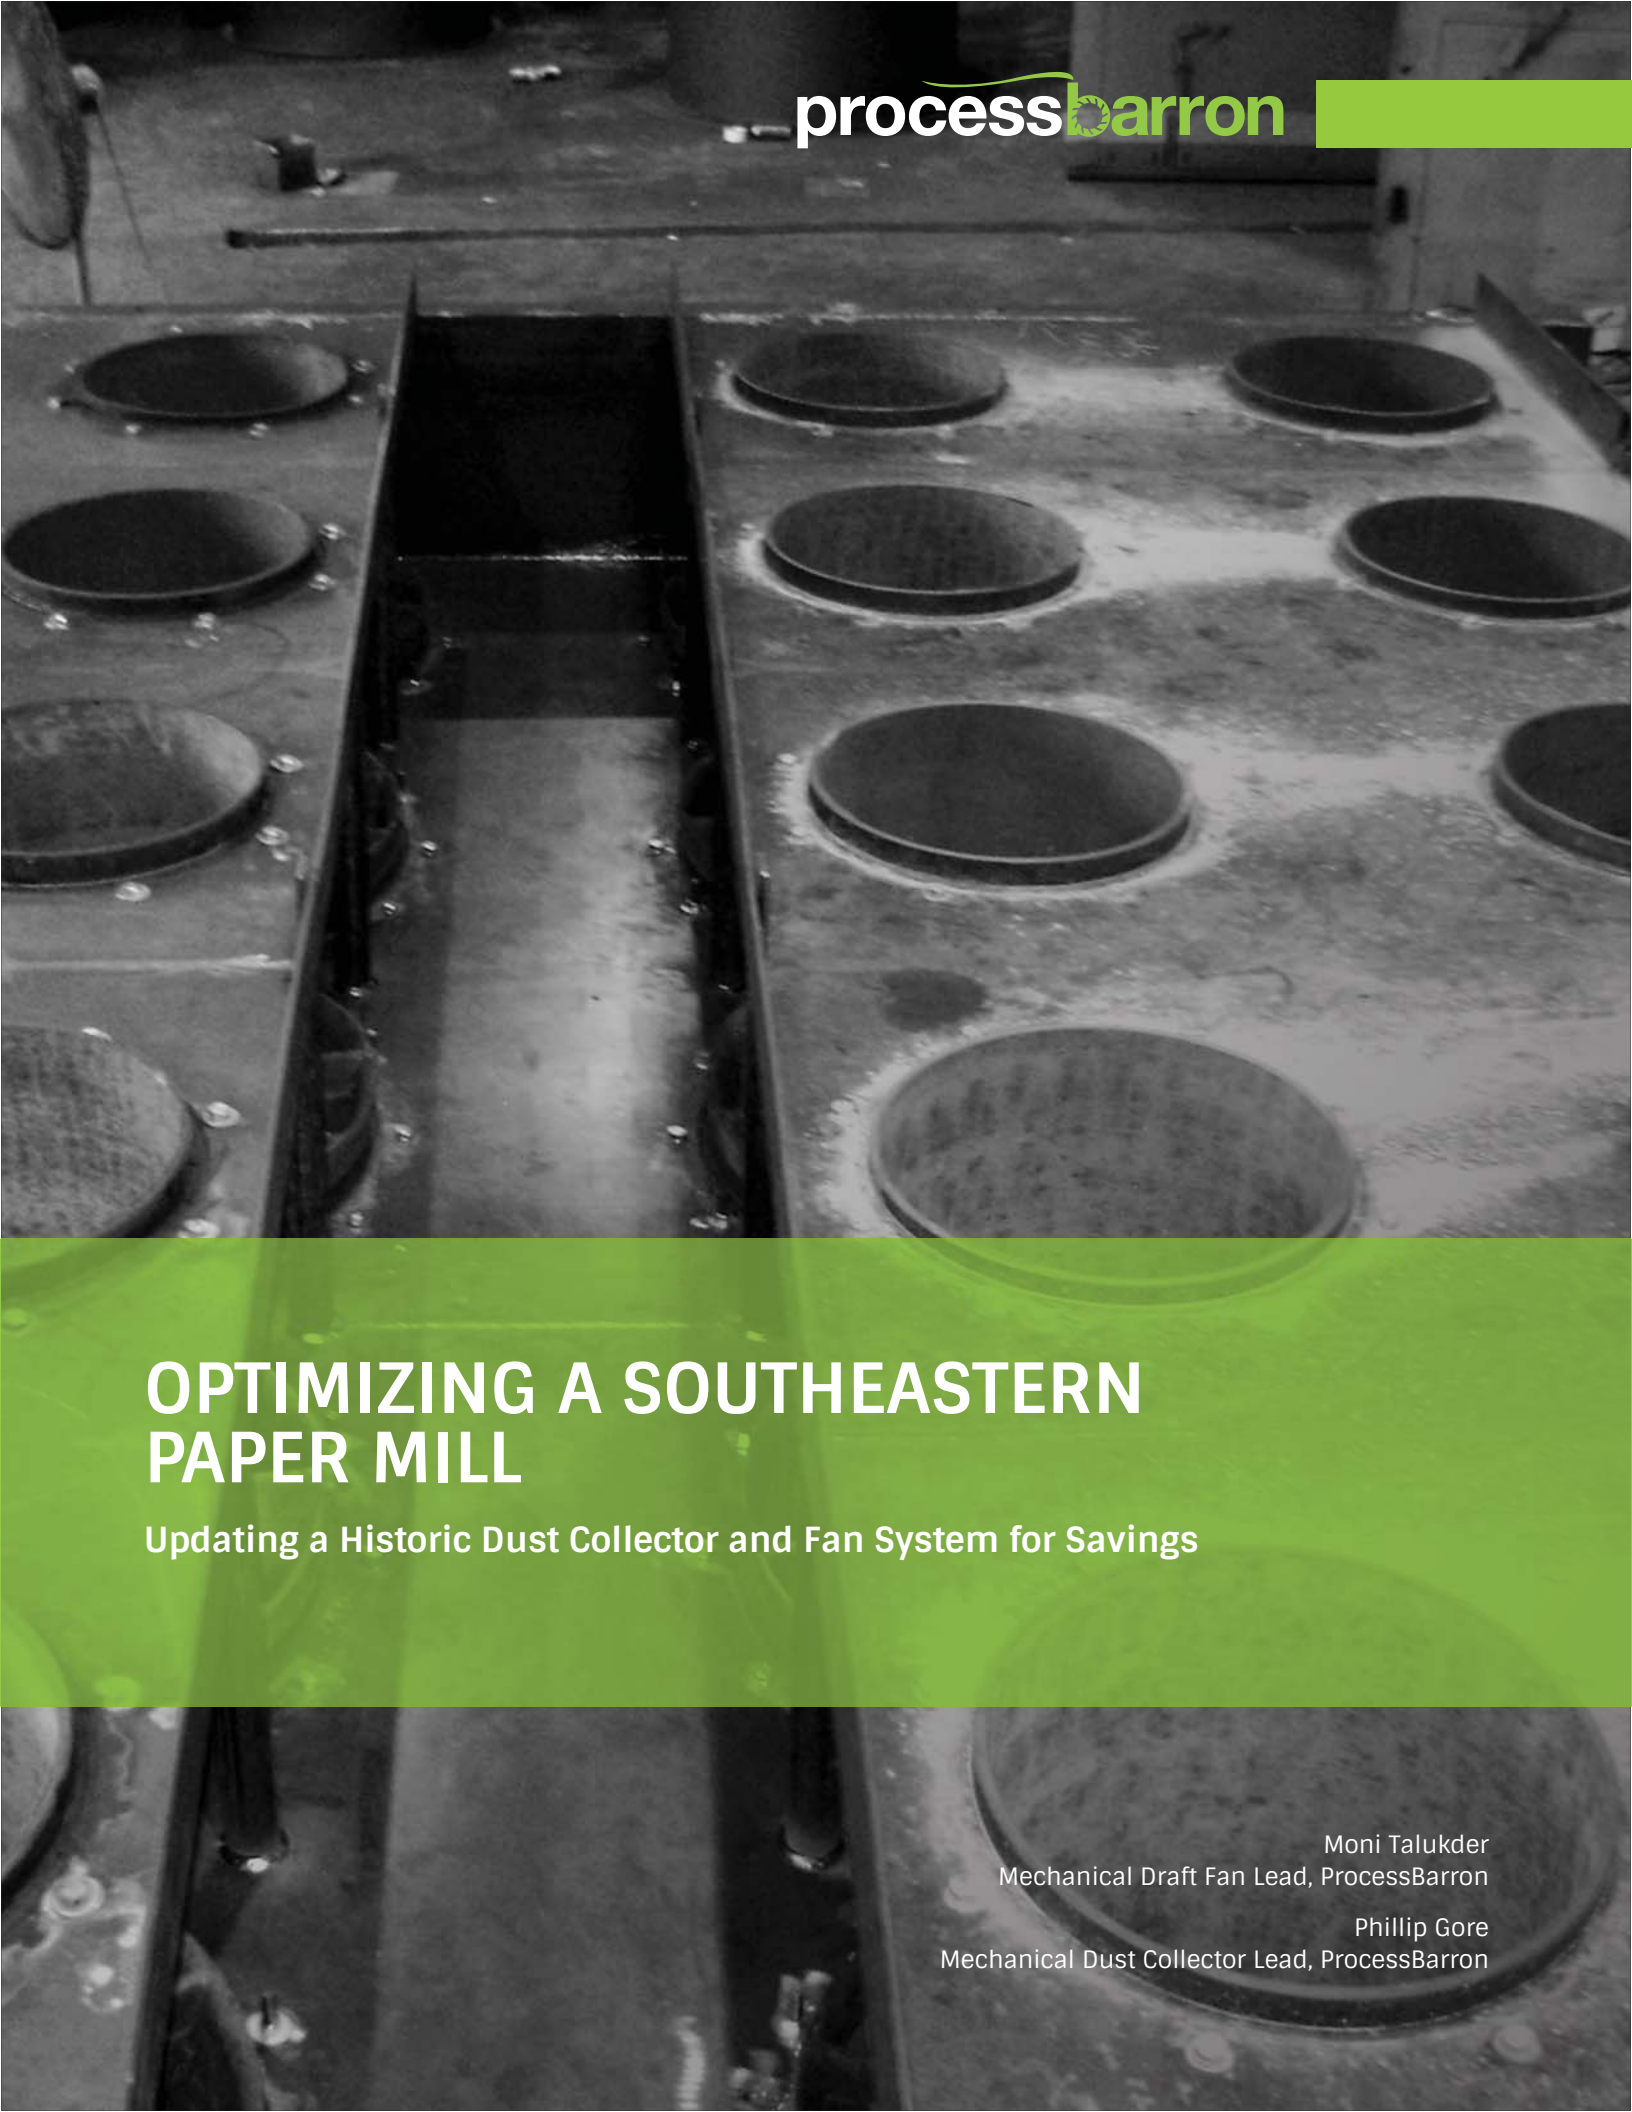
A black and white photograph of a paper mill's machinery, showing a long conveyor belt with several circular rollers or hoppers on top. The machinery is industrial and appears to be part of a dust collection or material handling system.

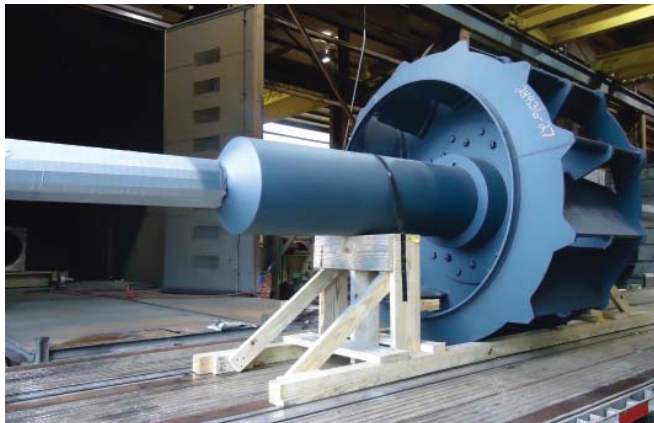
The paper mill ID fan was retrofitted with a radial-tip rotor at ProcessBarron headquarters in Pelham, Ala., and then installed in the existing fan casings at the mill.

The ultimate solution was a daring stroke of engineering ingenuity: ProcessBarron would work with all existing casings, all existing geometry, and all existing footprints in the system but gut the internals of the three dust collectors. Essentially, the dust collectors were reduced to empty boxes — each just another piece of the ductwork. The casing of one of the original collectors was then used to create a single, efficient dust collector. Twenty-four-inch collection tubes were installed to cope with the large air volume required by the system. The ID fan was then retrofitted with a 74.5-inch optimized heavy-duty radial-tip rotor, customized to fit the existing fan housing.
